## Minerals Inspection Report

Report Date: **04/21/2014**

Mine Name: Snowball Mine	Permit Number: M/037/0026	Mine Status: Active
Operator Name: Energy Fuels Resources (USA)	Inspection Date: 04/15/2014	Permit Fees: Paid
Inspector(s): M. Bradley	Inspection Time: 10:45a	Bond Amount: \$348,686
Attendee(s): See below	Weather: Pt. Cldy, cool	Bond Escalation: 09/21/2015
Inspection Purpose: Routine inspection		Prior Inspection: 06/13/2013

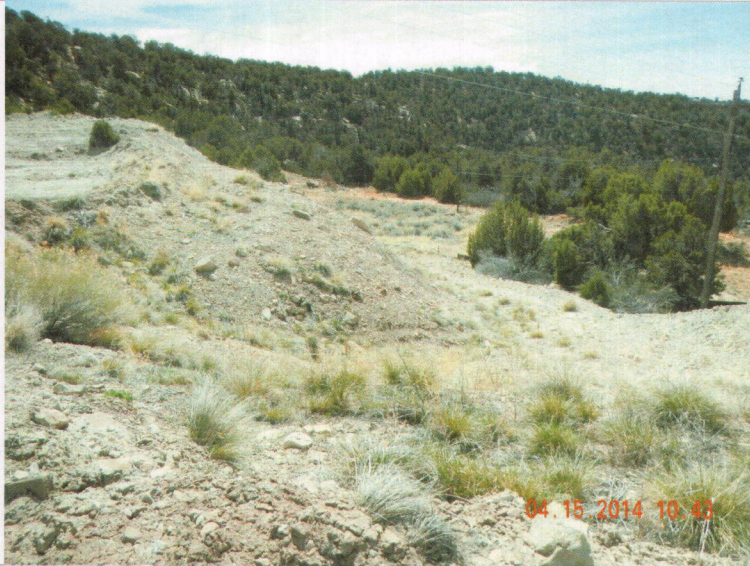
Attendees: Becky Doolittle, BLM; Joe Manning, BLM; Andrea Reither, Stephen Downs, EFR; EFR; Race Fisher, EFR; Todd Eldredge, EFR.  
No significant changes since last inspection. Some erosion off southwest flank of waste rock pile (see photo). Portal still sealed. No visible evidence of eminent threats to public health and safety.

View of west side of waste rock pile looking south

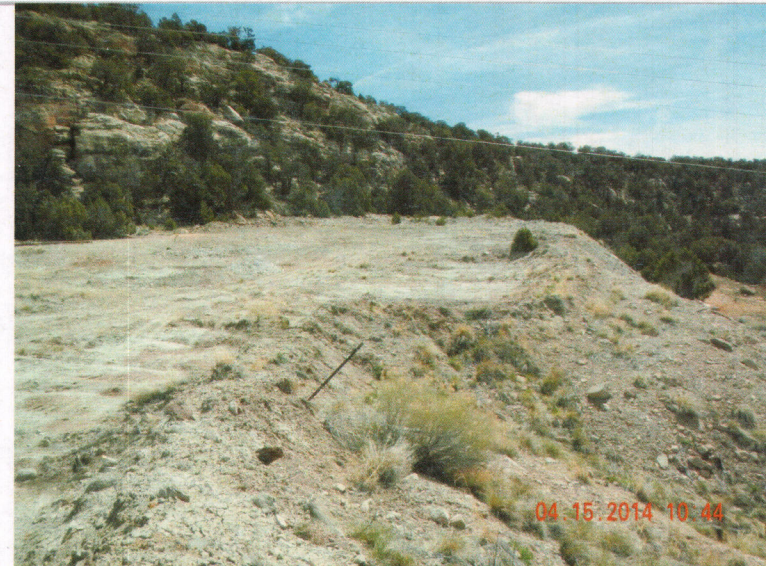
8. <i>Soils</i>	<input type="checkbox"/>	<input type="checkbox"/>
9. <i>Revegetation</i>	<input checked="" type="checkbox"/>	<input type="checkbox"/>
Discussed areas that should have temporary revegetation seeding for temporary suspension

View of top of waste rock pile where temporary seeding is recommended

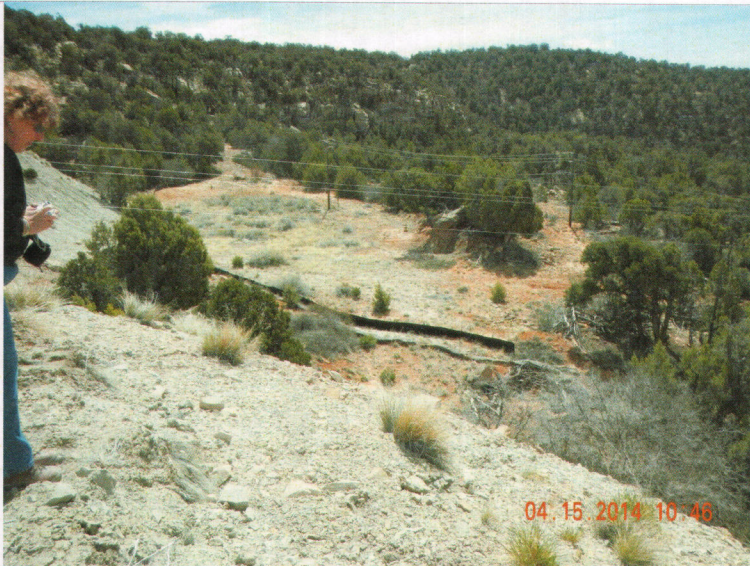
View of silt fence at toe of waste rock pile

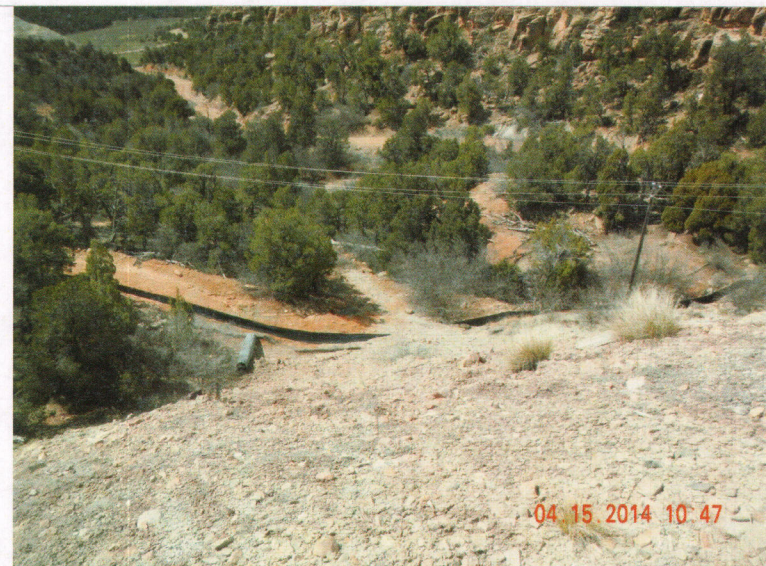
2. <i>Public Safety (shafts, adits, trash, signs, highwalls)</i>	<input checked="" type="checkbox"/>	<input type="checkbox"/>
Portal remains sealed		
3. <i>Protection of Drainages/Erosion Control</i>	<input checked="" type="checkbox"/>	<input type="checkbox"/>
Some erosion off of southwest flank of waste rock pile has overtopped the silt fence at the toe (see photo). Silt fence needs to be cleaned out and repaired as needed.

View of sediment overtopping silt fence (near center of photo).

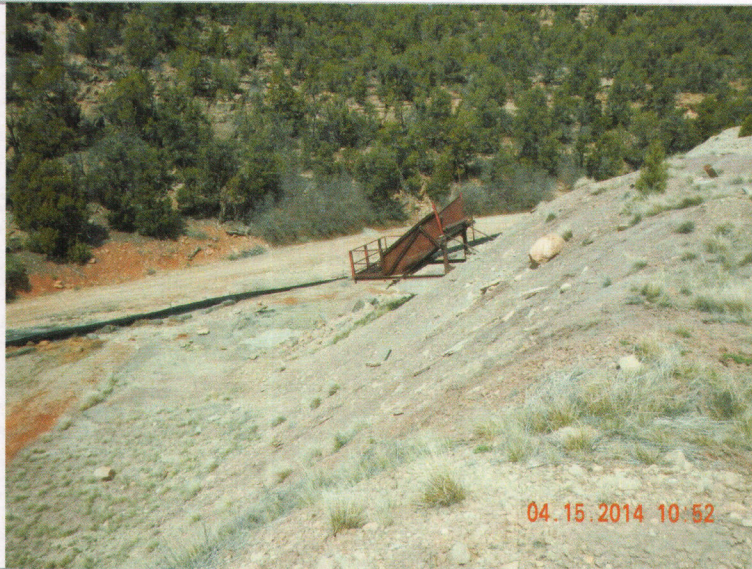
View of grizzly left on slope of waste rock pile

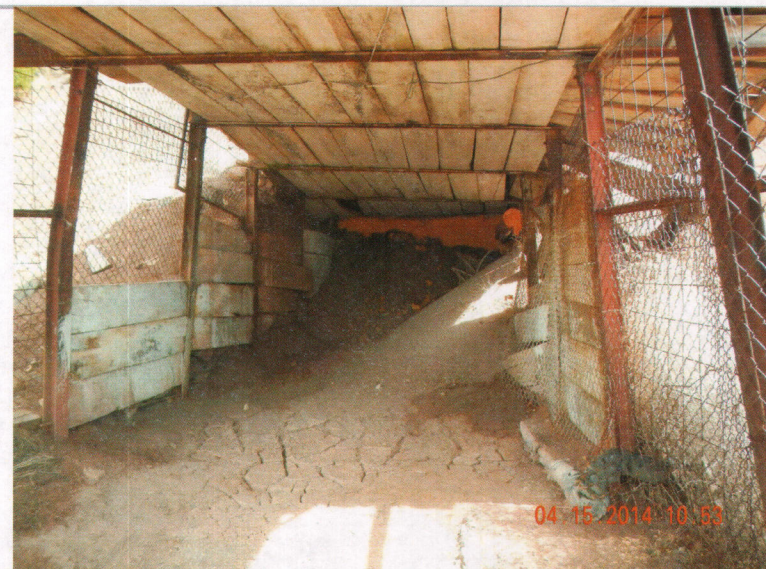
View into sealed shaft
